SAFETY CAMPAIGN

2018

PILOT LADDER SAFETY SURVEY 2018

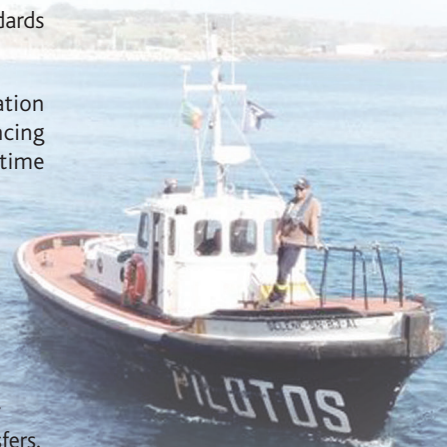
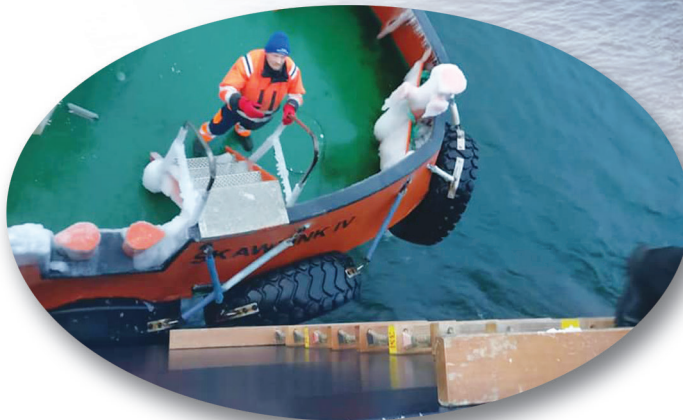
Right and below: Compounding the danger to Pilots of non-SOLAS compliant Boarding Arrangements, is the efforts of some Administrations to force Pilots to use Elderly or Unsuitable vessels (like Tugs) to executive transfers. These two examples are both from Europe.

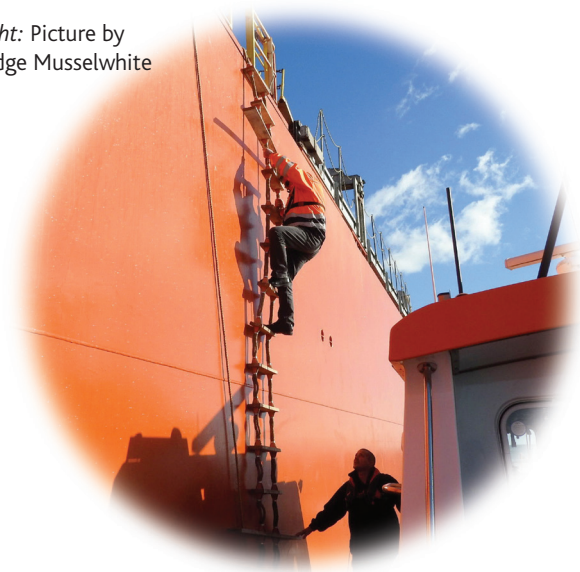
COMPLIANCE BY REGION

The chart below shows 4,339 returns from participating IMPA members which have been grouped into 6 geographical areas. The total non-compliance is shown as a percentage of total returns from each region and as a total.

COUNTRY	TOTAL RETURNS	COMPLIANT	NON COMPLIANT	NON COMPLIANT AS %
Africa	100	81	19	19.00
Asia / Oceania	810	687	123	15.19
Europe	1679	1442	237	14.12
Middle East	79	71	8	10.13
North America	371	297	74	19.95
South America	1300	1191	109	8.38
TOTAL	4339	3769	570	13.14

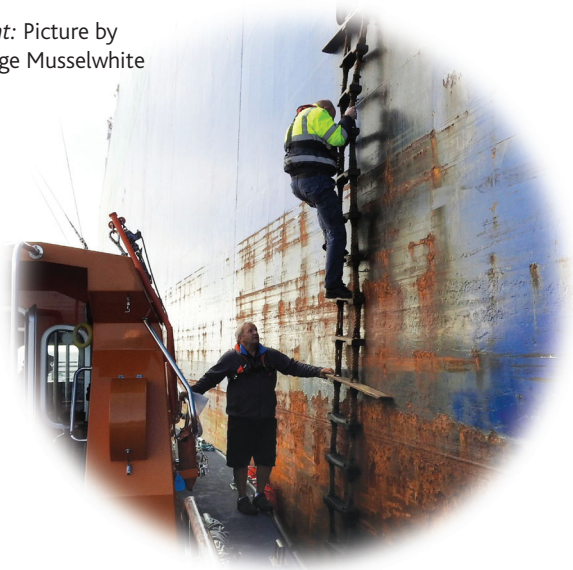
COMPLIANCE BY VESSEL TYPE

The following chart shows a break down of all returns by vessel type. Both the number and the percentage of non-compliant vessels by type are shown.

VESSEL TYPE	TOTAL NUMBER OF VESSELS	COMPLIANT	NON COMPLIANT	NON COMPLIANT AS %
General Cargo	621	519	102	16.43
Oil Tanker	712	628	84	11.8
Ro/Ro	162	148	14	8.64
Passenger	233	208	25	10.73
Container	946	830	116	12.26
Gas Tanker	165	154	11	6.67
Reefer	22	18	4	18.18
Fishing	13	8	5	38.46
Bulkcarrier	603	503	100	16.58
Chemical Tanker	308	267	41	13.31
Car Carrier	106	95	11	10.38
Rig Supply Vessel	115	97	18	15.65
Other (E.G. Navy)	400	352	48	12

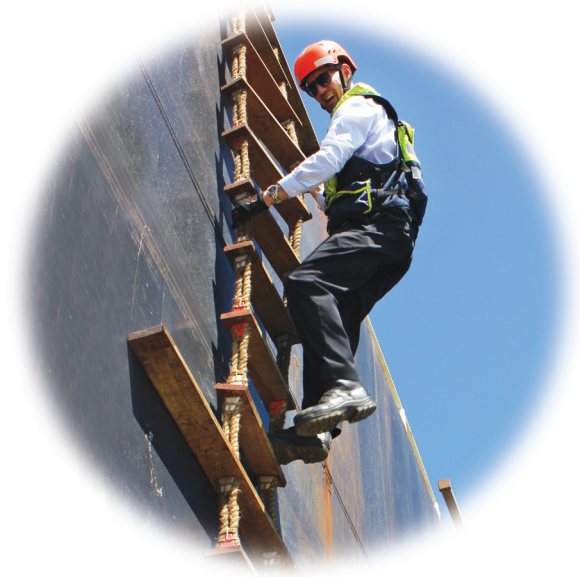
COMPLIANCE BY MEANS OF TRANSFER

The following chart shows a breakdown of all returns by means of transfer. Both the number and the percentage of non-compliant means of transfer by type are shown.

MEANS OF TRANSFER	TOTAL NUMBER	COMPLIANT	NON COMPLIANT	NON COMPLIANT AS %
Pilot Ladder	2729	2397	332	12.17
Combination	956	805	151	15.79
Side Door and Pilot Ladder	455	396	59	12.97
Gangway	82	76	6	7.32
Helicopter	45	42	3	6.67
Deck to Deck	164	136	28	17.07
TOTAL	4431	3852	579

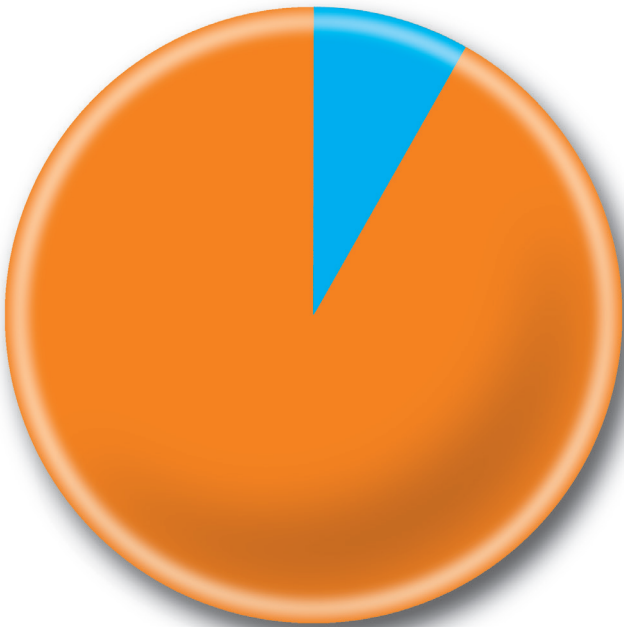
DEFECTS REPORTED TO AUTHORITY

The first pie chart shows the percentage of the defects that were reported to the Authority. The second pie chart shows non-compliance by type of defect. Both the number and percentage are shown.

TOTAL NUMBER OF NON-COMPLIANT SHIPS IN SURVEY REPORTED	570
Number of defects reported to Authority	46
% of non-compliant ships reported	8.07
% of ships reported	8.07
% of ships not reported	91.93

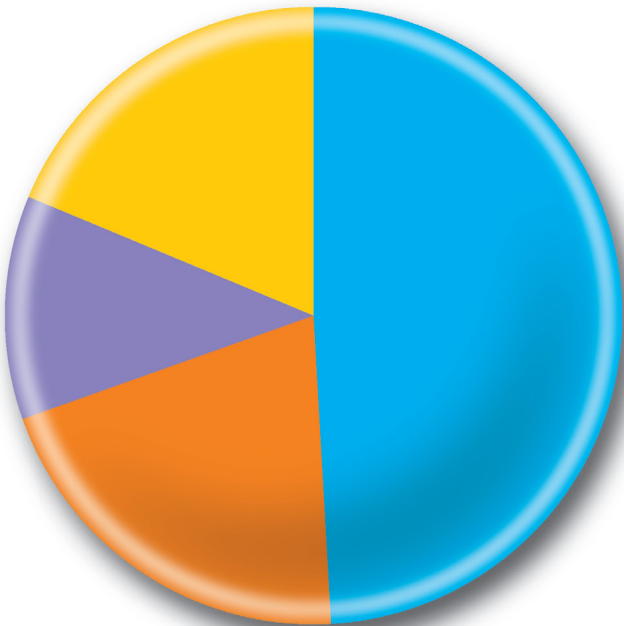
NON-COMPLIANCE BY TYPE OF DEFECT

NON-COMPLIANT BY TYPE OF DEFECT	TOTAL	AS %
Pilot ladder	337	49.2
Bulwark/Deck	140	20.44
Combination	83	12.12
Safety Equipment	125	18.25
TOTAL	685

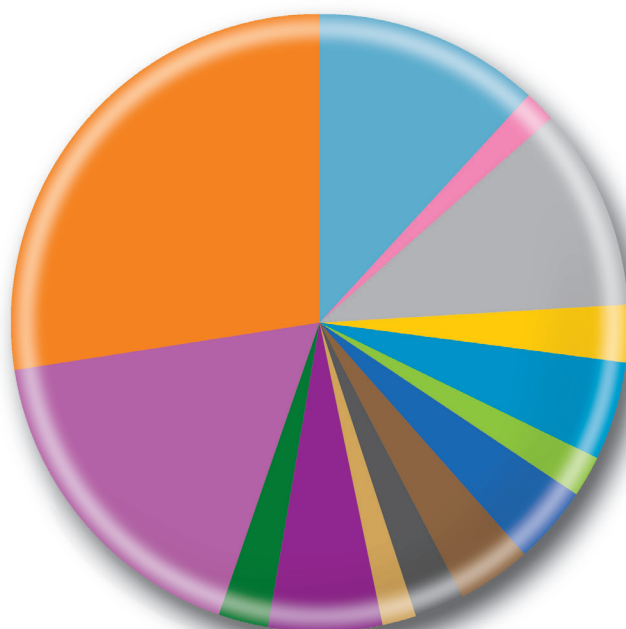
The first pie chart shows the types of defects of the pilot ladder. Both the number and percentage are shown. The second pie chart shows the types of defects of the bulwark / deck arrangements. Both the number and percentage are shown.

DEFECTS OF PILOT LADDER	TOTAL	AS %
Not against ship's hull	57	11.75
Steps not of suitable material	8	1.65
Poorly rigged retrieval line	51	10.52
Steps broken	14	2.89
Steps not equally spaced	26	5.36
Pilot Ladder more than 9 metres	10	2.06
Steps dirty/slippy	20	4.12
Sideropes not of suitable material	19	3.92
Pilot Ladder too far forward/Aft	14	2.89
Steps painted	8	1.65
Incorrect step fittings	29	5.98
No bulwark ladder	11	2.27
Steps not horizontal	87	17.94
Other	131	27.01
TOTAL	485

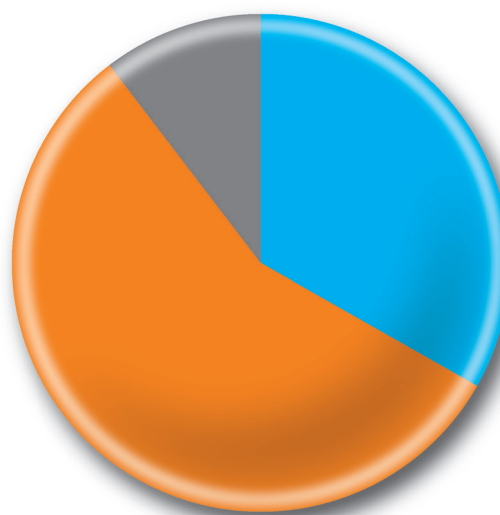
DEFECTS OF BULWARK / DECK	TOTAL	AS %
No/faulty handhold stanchions	52	33.55
Ladder not secured properly	87	56.13
Other	16	10.32
TOTAL	155

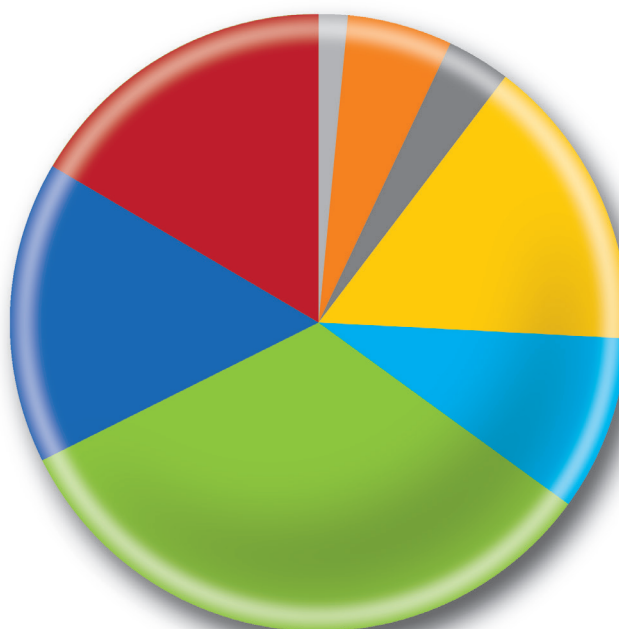
The first pie chart shows the combination defects. Both the number and percentage are shown. The second pie chart shows the safety equipment defects. Both the number and percentage are shown.

COMBINATION DEFECTS	TOTAL	AS %
Accommodation Ladder not leading aft	3	1.65
Lower platform stanchions / rail incorrect rigged	10	5.49
Accommodation ladder too steep (>45 degrees)	6	3.3
Pilot Ladder not attached 1-5m above Accommodation Ladder	28	15.38
Lower platform not horizontal	17	9.34
Ladder(s) not secured to ship's side	59	32.42
Lower platform less than 5 metres above the sea	29	15.93
Other	30	16.48
TOTAL	182

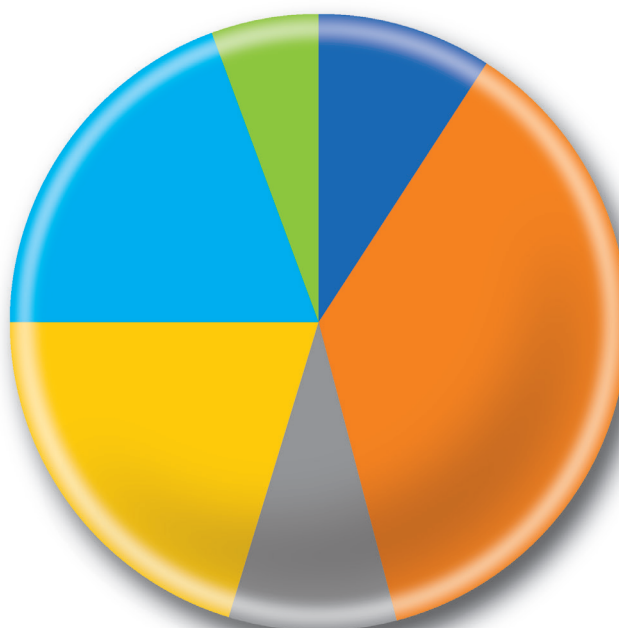
SAFETY EQUIPMENT DEFECTS	TOTAL	AS %
Inadequate lighting at night	18	9.14
No lifebuoy with self-igniting light	73	37.06
No VHF communication with the bridge	17	8.63
No heaving line	40	20.3
No responsible officer in attendance	38	19.29
Other	11	5.58
TOTAL	197

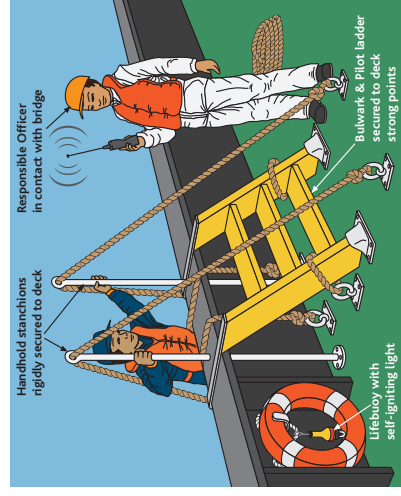
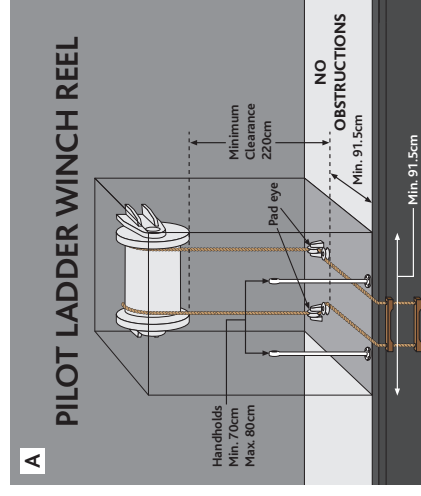
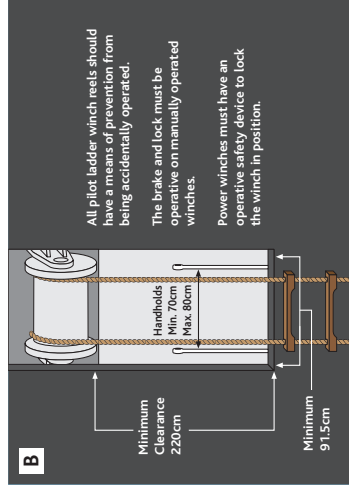
REQUIRED BOARDING ARRANGEMENTS FOR PILOT

In accordance with SOLAS Regulation V/23 & IMO Resolution A.1045(27)
