# PILOT LADDER REQUIREMENTS AND GUIDANCE

## Required Boarding Arrangements for Clydeport Pilots

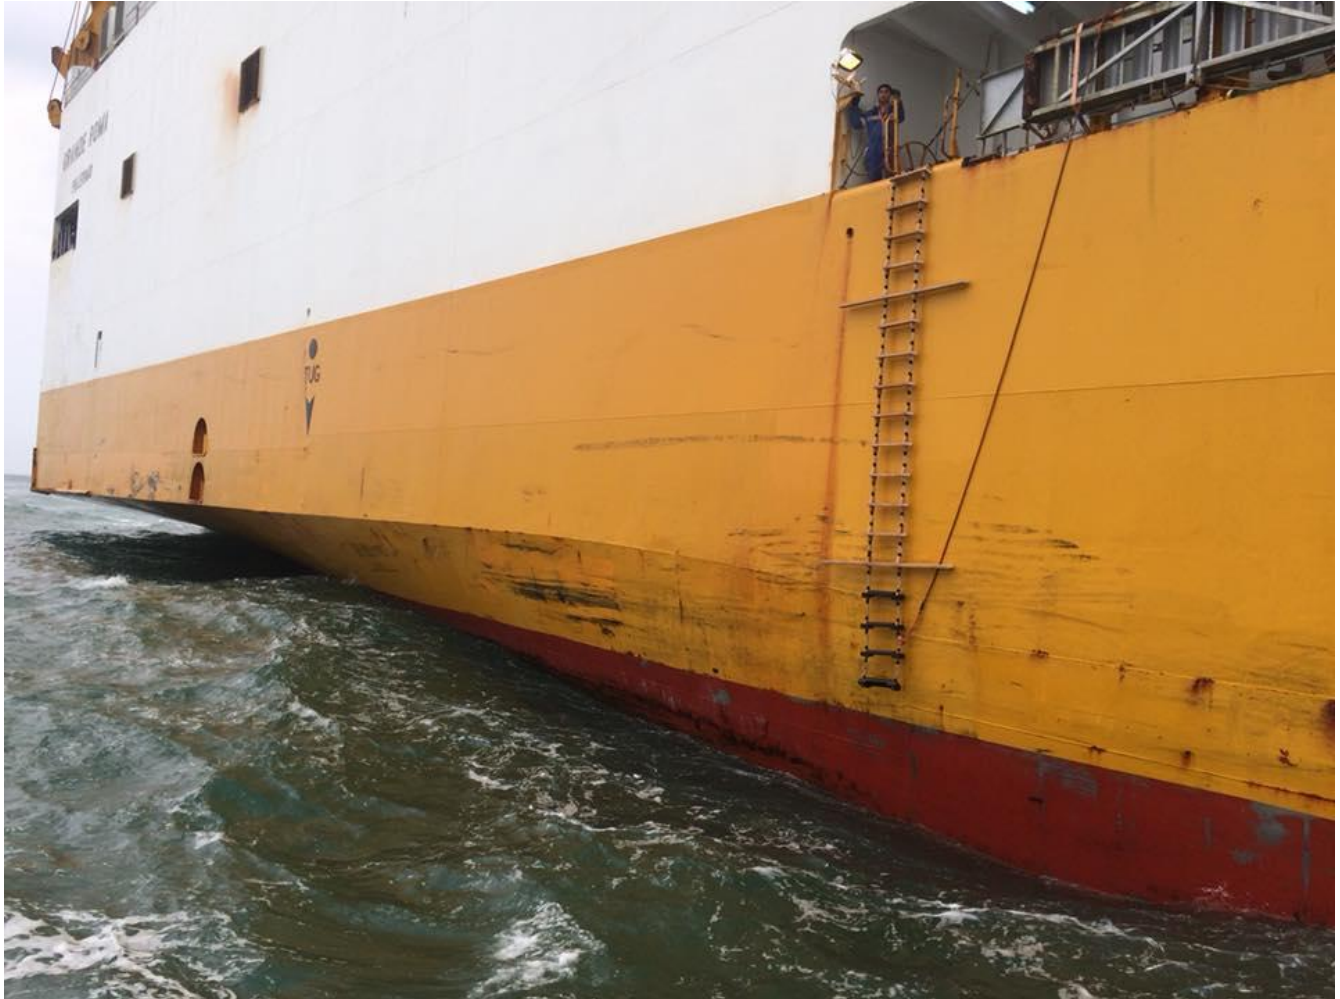
In the above picture the pilot ladder is situated too far aft. The pilot boat would sit in the cut-away of the hull (also note that the tripping line is rigged too low).
