### Pilot Ladder break aboard the M.T. Rio Daytona 30/1/13

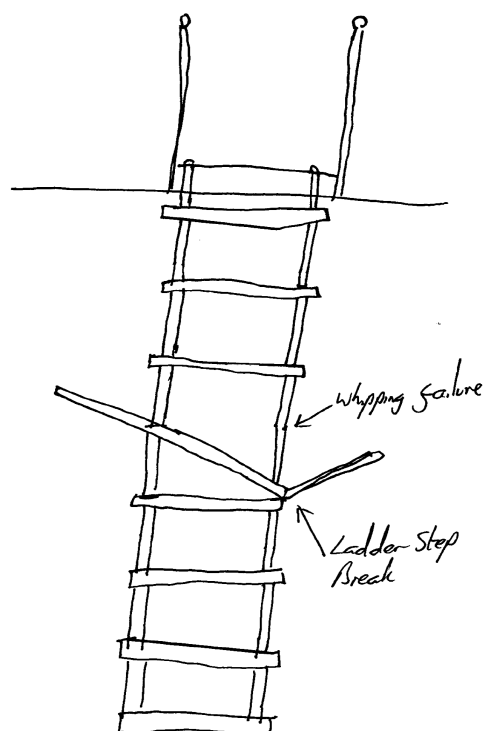
The spreader was approximately half way down the ladder which was approximately 3m long with the end 1.5m from the waterline. Thankfully the step collapsed when I had both hands on the sideropes and the vessel had been manoeuvred close inshore to gain a good lee.

Although I arrested myself mainly using my arms the end result was a jarred knee. No photo was taken as I needed to get myself into the cabin to take the weight off the right knee. I attach a rough sketch of the view of the ladder from the Launch after disembarking.

The ladder was in generally good condition and looked reasonably new. I consider the step was damaged during handling of ladder by deck crew at some stage and either not seen or ignored. The step failed under little weight. The damage could not have been seen by me or the launch prior to disembarking.
